Manhole Inspection Summary

Manhole # S33M__029MH

Insp Date: **3/7/08 8:47 AM**

Location Address: **616 hanover**

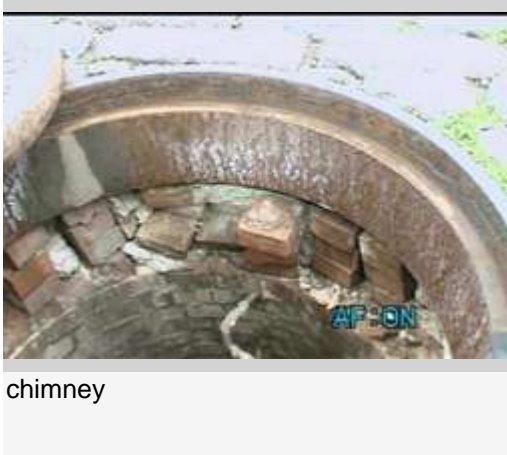
Defect 2

Condition: ☐ Sound ☐ Cracked ☐ Root Intrusion ☒ **Loose Brick** ☐ Deteriorated

chimney

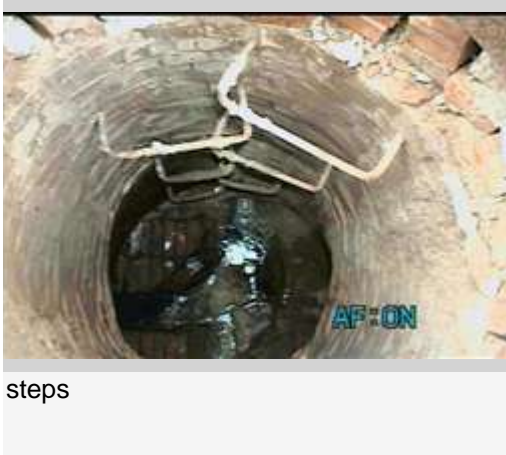
Defect 1

Steps Count: **6** Missing: **0** ☒ **Corroded**

steps

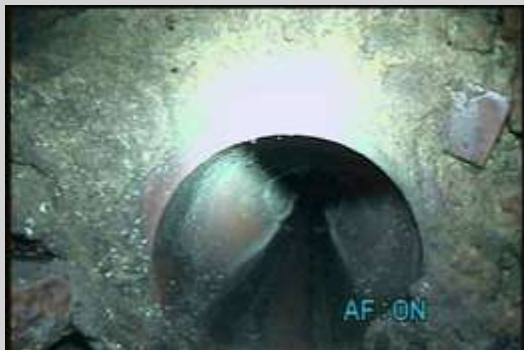
12 O'Clock Outflow

8 in. Circular Gravity Sewer
Pipe Out @ 12 O'Clock

Pipe Material: **Clay** ☐ Pipe Lined

Invert Depth: **10.50** (ft.) Flow Characteristics: **Slow**

Deposits: ☒ None ☐ Mud ☐ Sludge ☐ Debris ☐ Grease

Infiltration: **None** Pipe Seal Cond: **Unknown**

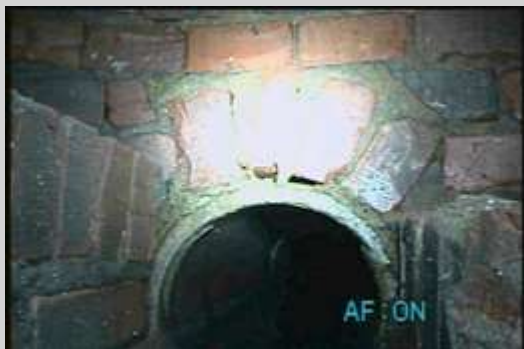
6 O'Clock Inflow

8 in. Circular Gravity Sewer
Pipe In @ 6 O'Clock

Pipe Material: **Clay** ☐ Pipe Lined

Invert Depth: **9.80** (ft.) Flow Characteristics: **Slow**

Deposits: ☒ None ☐ Mud ☐ Sludge ☐ Debris ☐ Grease

Infiltration: **None** Pipe Seal Cond: **Unknown**

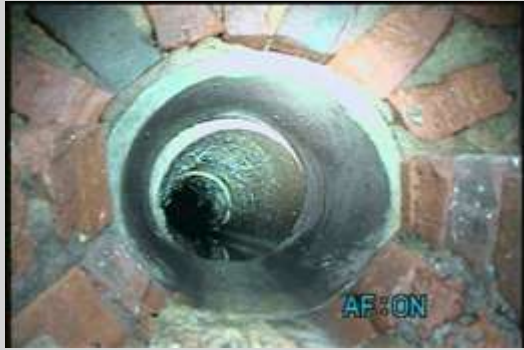
9 O'Clock Inflow

8 in. Circular Gravity Sewer
Pipe In @ 9 O'Clock

Pipe Material: **Clay** ☐ Pipe Lined

Invert Depth: **9.80** (ft.) Flow Characteristics: **Slow**

Deposits: ☒ None ☐ Mud ☐ Sludge ☐ Debris ☐ Grease

Infiltration: **None** Pipe Seal Cond: **Unknown**
